# **TEST REPORT**

NAME OF SAMPLE	HAND-HELD DETECTOR				
TYPE	ULTRA SCANNER				
TRADEMARK	Nokta Engineering				
CLIENT	NOKTA MUHENDISLIK INS.ELEK.PLAS. GIDA VE REKLAM SAN.TIC.LTD.STI.				
ADDRESS OF CLIENT	SIVATYOLU CAD. SAKIZ SOK. NO4 SANCAKTEPE ISTANBUL TURKEY				
INSPECTION CLASSIFICATION	Client Entrust				
TEST ITEM	Low & High temperature test

# Low & High temperature test

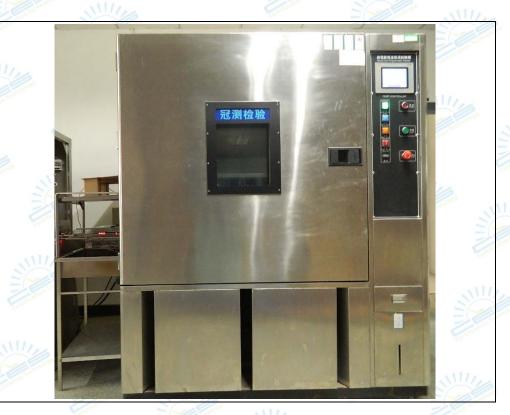
## Photo 3

View: during low temperature test

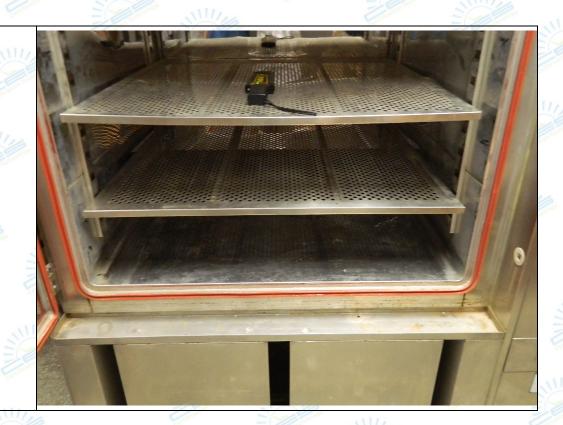
## Photo 4

Test results	No abnormal function and no damage of appearance.					
Verdict	Pass

View: after test
